VIBRATING TEST REPORT

NTC-SR2505012

TEST REPORT							
Luminaires							
Part 1: General re	Part 1: General requirements and tests — Luminaire Vibration						
Report Reference No:	NTC-SR2505012						
Date of issue:	May.10, 2025						
Total number of pages:	6 Pages						
Testing Laboratory:	Dongguan New Testing Centre Co., Ltd.						
Address:	1F & 3F, No. 1 the 1st North Industry Road Songshan Lake Science & Technology Park Dongguan, People's Republic of China 523808						
Tested by (name + signature):	Jack Zhang						
Approved by (+ signature)	Neil Zhong						
Approved by (+ signature): Applicant's name:	MIC Optoelectronic CO., LTD						
Address	2nd floor,Third Building, 97# AiNan Road,LongDong, BaoLong Street, LongGang District, Shenzhen, China						
Manufacturer's name:	MIC Optoelectronic CO., LTD						
Address:	2nd floor,Third Building, 97# AiNan Road,LongDong, BaoLong Street, LongGang District, Shenzhen, China						
Standard :	IEC 60598-1:2020 4.20 Rough service luminaires – Vibration requirements IEC 60068-2-6:2007

Test specification:							
Procedure deviation:	N/A						
Non-standard test method :	N/A						
Testitem description:	LED Street Light						
Trade mark :	MIC

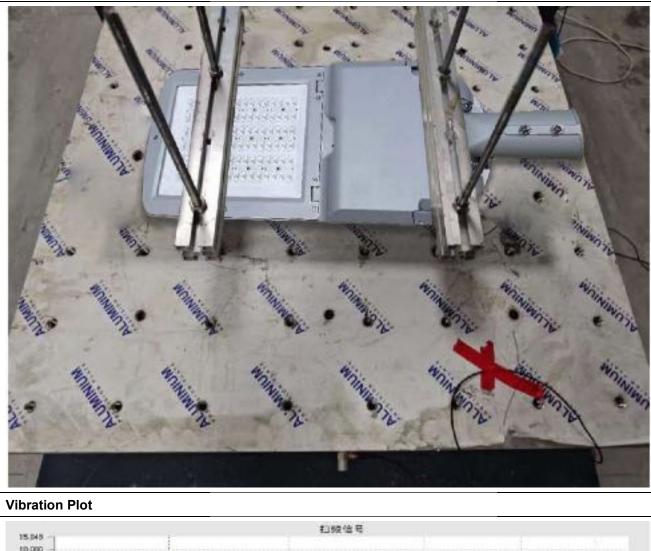
Setup Photo Test model:MSL-F150, Axis: Vibration (X-axis)

The sample was tested in the X-axis direction. no significant changes were found in the test sample. The fixture can light up and function after the vibration endurance testing. Test result: Pass

Vibration Test Frequency		Test Duration	Vibration Amplitude	Test result	
X-axis	10 Hz, 55 Hz, 10 Hz	30 min	0,35 mm	Pass	
Y-axis	10 Hz, 55 Hz, 10 Hz	30 min	0,35 mm	Pass	
Z-axis	10 Hz, 55 Hz, 10 Hz	30 min	0,35 mm	Pass

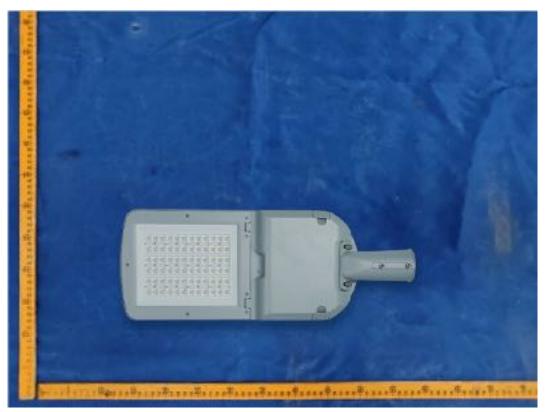
Picture 1: The overview (Model: MSL-F150)

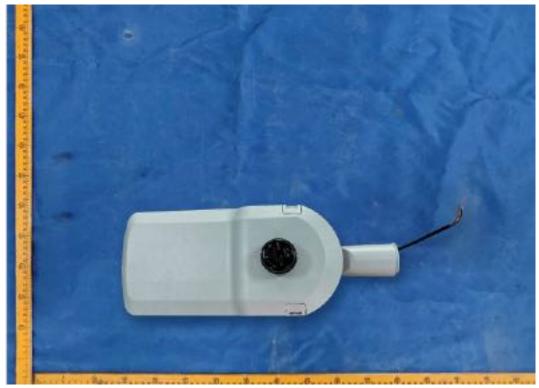
Picture 2: The overview (Model: MSL-F150)
